REHABILITATION OF NAVIGATION LOCK WALLS: CASE HISTORIES

James E. McDonald

Structural Laboratory

December 1987

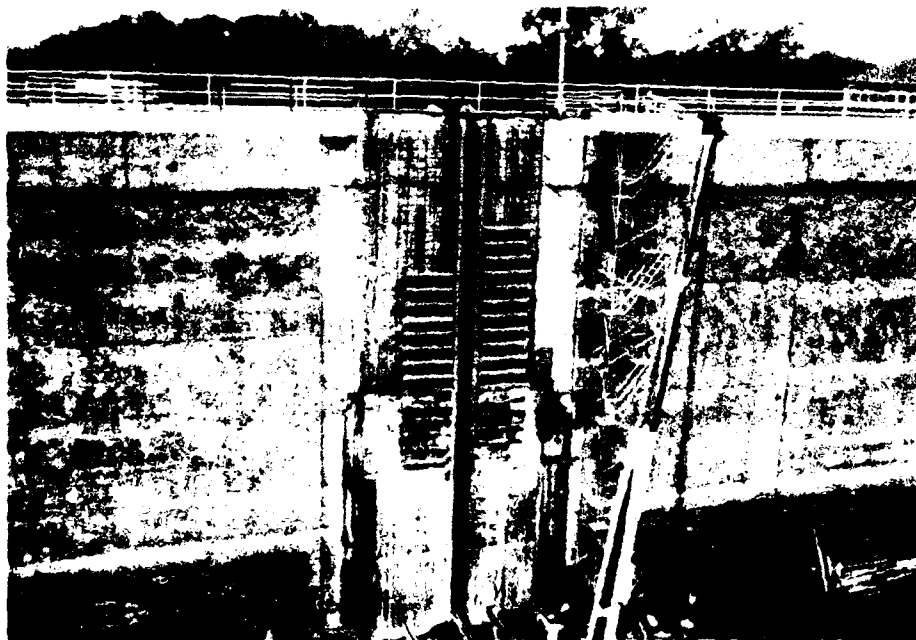
Figure 154. Partially completed ladder section,
Lockport Lock

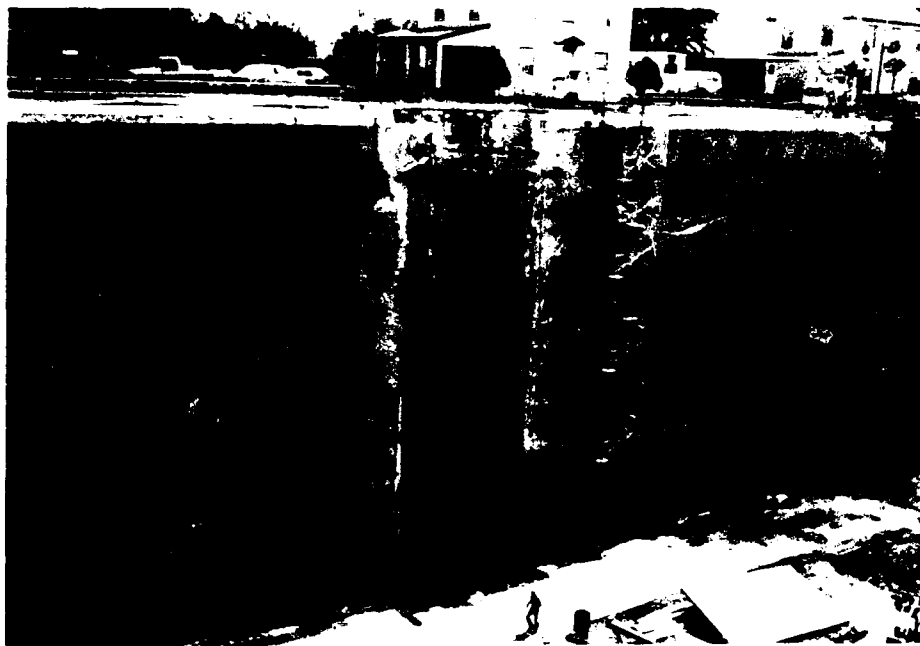
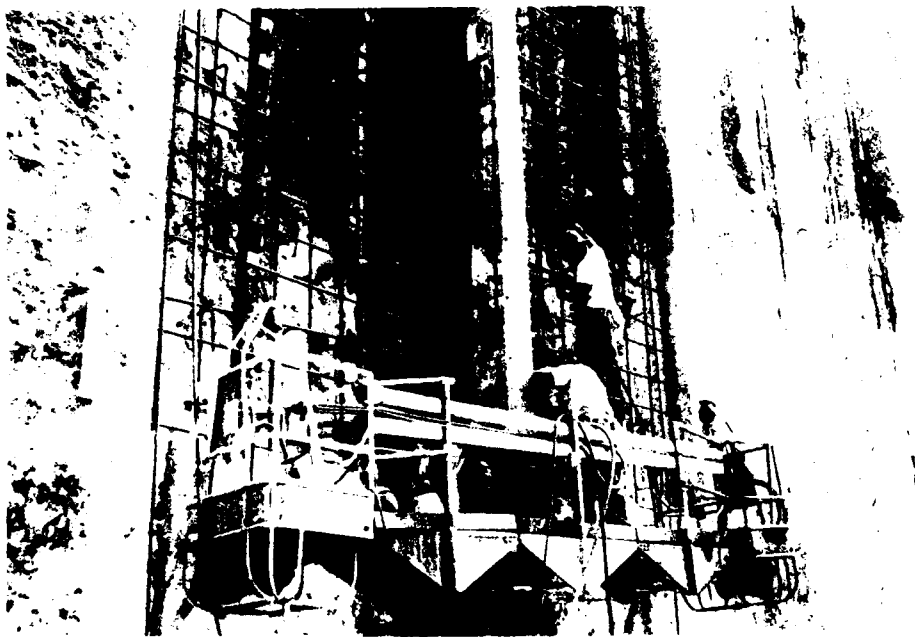
324. Deteriorated concrete around the floating mooring bitts was removed and replaced with armored concrete as shown in Figures 156 through 160. The replacement required removal of approximately 110 cu yd of concrete. Approximately 470 dowels were used to anchor the replacement concrete. Concrete removal, installation of dowels, forming, and concrete placing were accomplished using techniques similar to that previously described for the exit ladders. The contractor's bid price for this work was approximately \$240,000.

Figure 160. Replacing concrete around a floating mooring bitt,
Lockport Lock

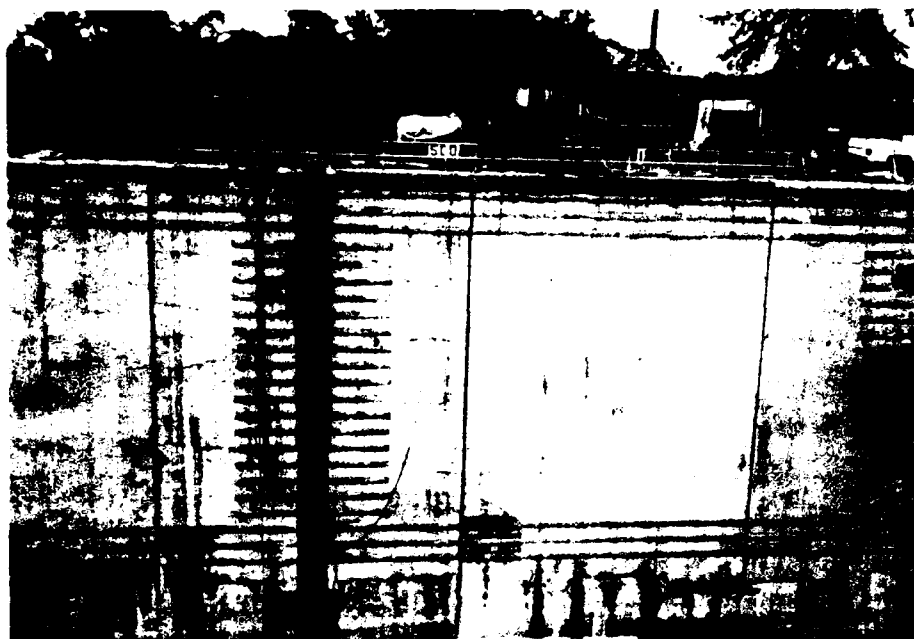
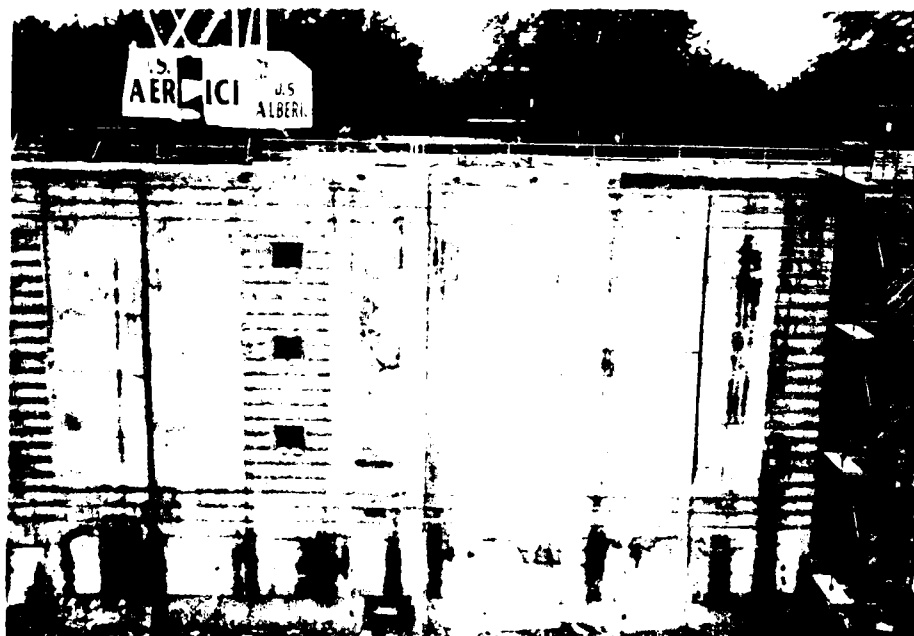
a. Landside wall

b. Riverside wall

Figure 179. Typical cracking in the replacement concrete
August 1984, Brandon Road Lock

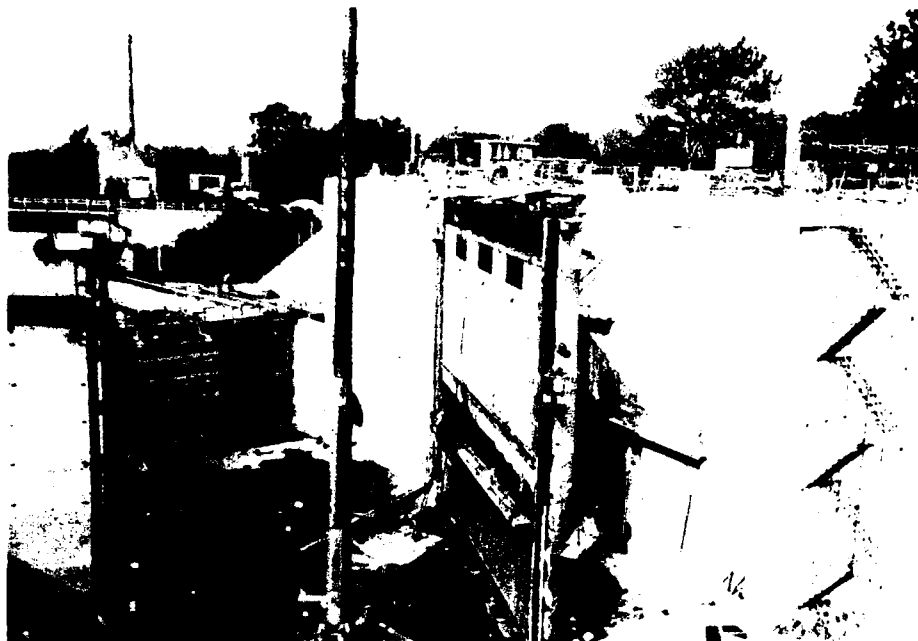
345. Rehabilitation of the upper and lower miter gates involved replacement of corroded rivets with high-strength bolts, replacement of corroded structural members, and sandblasting and painting of the entire gates (Figure 189). Many additional members that were not identified during the

a. Lower service gate being rehabilitated

b. Rehabilitated upstream miter gate ready for installation

Figure 189. Lock gate rehabilitation, Brandon Road Lock
